# Manhole Inspection Summary

Manhole # S33WW\_001MH

Insp Date: **4/13/07 12:23 PM**

**Location** Address: **3001 LOVEGROVE ST**

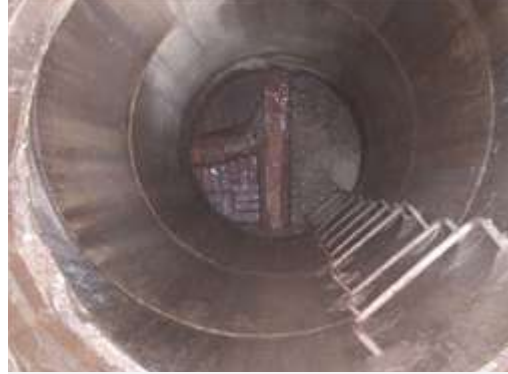
Top View

Bench debris.

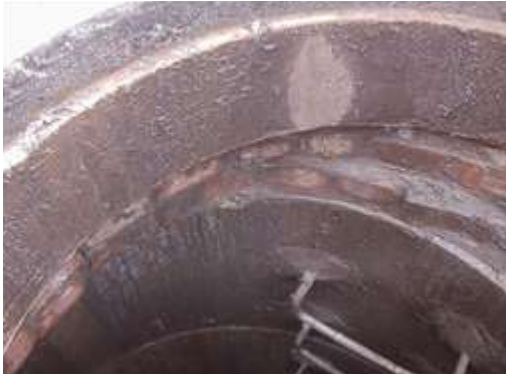
Defect

Frame leaks. Adjustment deterioration and infiltration. Corbel and Barrel infiltration - other side.

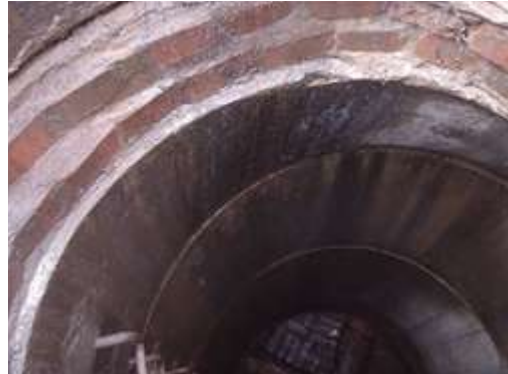
Defect

Frame leaks. Adjustment deterioration and infiltration. Corbel and Barrel infiltration.

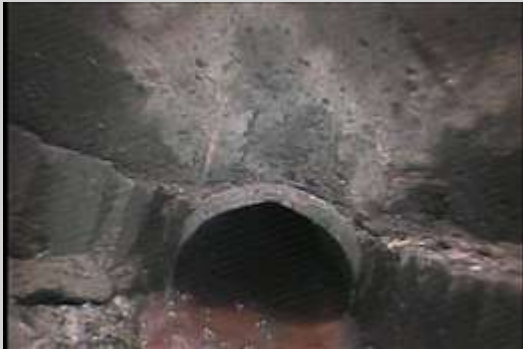
### 8 in. Circular Gravity Sewer Pipe Out @ 12 O'Clock

Channel deterioration.

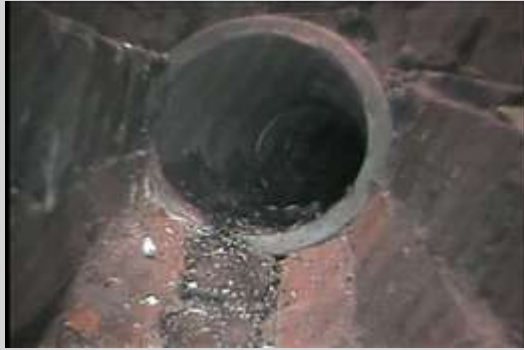
Pipe In @ 9 O'Clock

Deposits: ☐ None ☒ **Mud** ☐ Sludge ☒ **Debris** ☐ Grease

Deposits Extent: **Light**
